Mormugao Port Trust, Goa

Risk Survey Report

21st April 2016

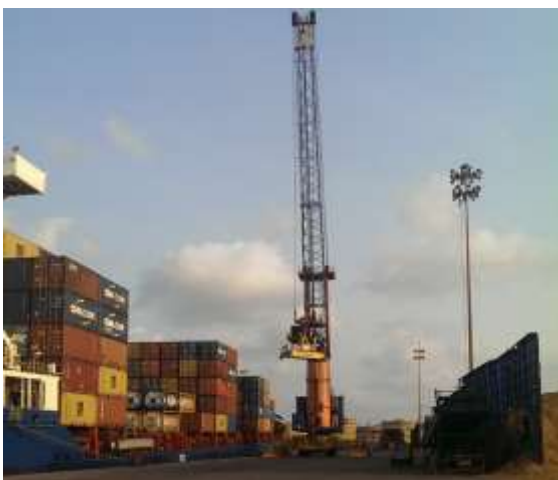
HMC

There is one Harbor Mobile Crane (HMC) provided for container handling purpose at berth no. 10&11. Maintenance of the equipment is under AMC contract.

Make: ITALGRU

Capacity * Radius

120 T * 11-20 m

37.5 T * 51 m

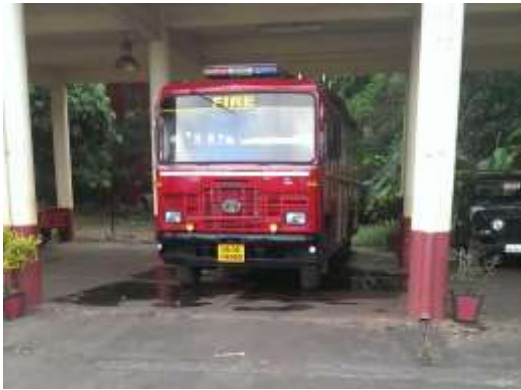
Fire Tender

For port area, there are two fire tenders available at site.

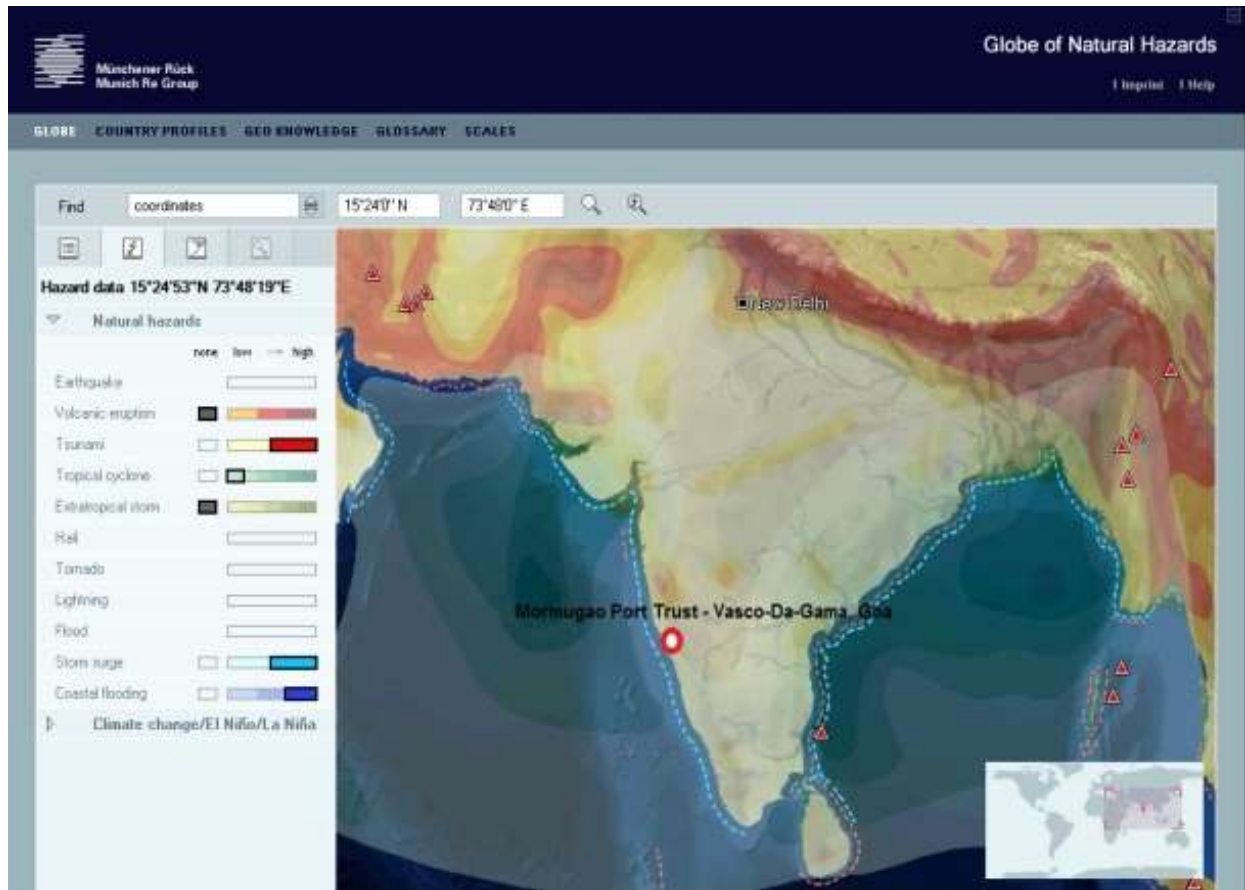
Natural Hazards Exposure (from Munich Re Natural Hazards Manual)

➤ **Natural Hazards Exposure (Pertaining to the location conditions)**

Peril	Exposure
Earthquake	No Data
Volcanic Eruption	Nil
Tsunami	Medium To High
Tropical Cyclone	Zone 0: Wind Velocity - 76-141 Km/Hour. Low.
Extratropical Storm	Nil
Hailstorm (Frequency and Intensity of Hailstorm)	No Data
Tornado	No Data
Lightning (Frequency of Lightning Strokes per sq.km. and year)	No Data
Flood	No Data
Storm Surge	Medium To High
Coastal Flooding	High

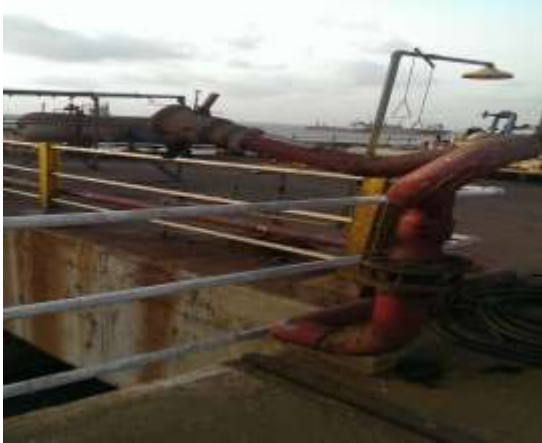
- It was observed that fire water monitor which is installed at berth no. 8 was not functioning. It is recommended that all the fire monitors installed at the site should be checked/tested from authorized services.

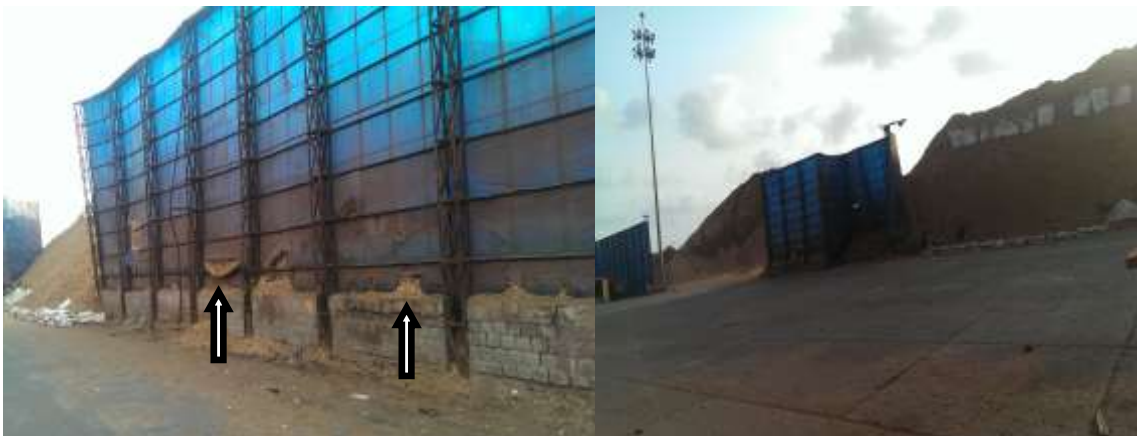
- It was observed that the protection sheet which has been placed for wood chips material in open shed area at berth no. 10&11 found to be damaged. It is recommended that it should be replaced with a new one so that material will not spread out of the sheet. It is also recommended that source of ignition should be avoided like open flames, hot gases, hot surfaces, mechanical sparks and electrical sparks, smoking at site etc. Wood chip piles can likewise pose a hazard. Fires from these piles can spread, burning and/or destroying adjoining properties.

Guidelines for storage of wood chips (from NFPA 230- Standard for the Fire Protection of Storage):

- a) Piles should not exceed 60 feet in height, 300 feet in width or 500 feet in length

- b) Piles should be separated from one another by approved fire apparatus access roads
 - c) Low barrier walls should be provided around piles to define pile perimeter and prevent creeping
 - d) Physical protection should be provided to prevent heat sources such as steam lines, air lines, electric motors and mechanical drive equipment from becoming buried or heavily coated with material
 - e) A minimum of 15 feet should be maintained between piles and exposing structures, yard equipment or stock depending on the degree of the exposure
 - f) Appropriate number of fire extinguishers suitable for Class A fires shall be provided in accordance with NFPA 10, Standard for Portable Fire Extinguishers
 - g) Monitor pile temperature routinely
- It is recommended that speed limit boards may be placed in the access roads of the berths to minimize the risk of impact damage from the vehicle.

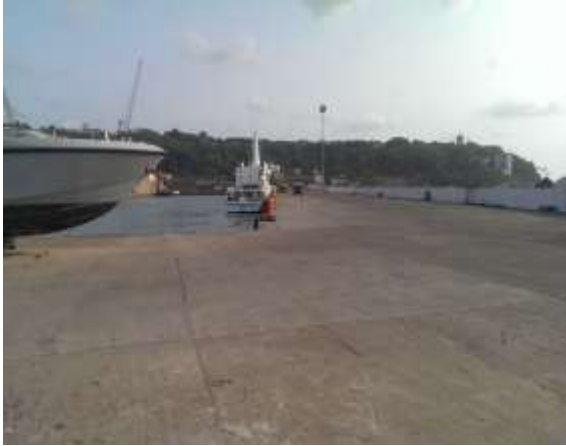
Breakwater Berth

The port has been provided with one breakwater berth and one mole berth. It is of RCC construction supported with number of piles and constructed in the year 2012. The length of the breakwater and mole is 500 mts and 300 mts respectively and width is 20 mts.

Breakwater and mole are also being used as a berthing for vessels. Breakwater can be used by one side only and mole can be used by both sides.

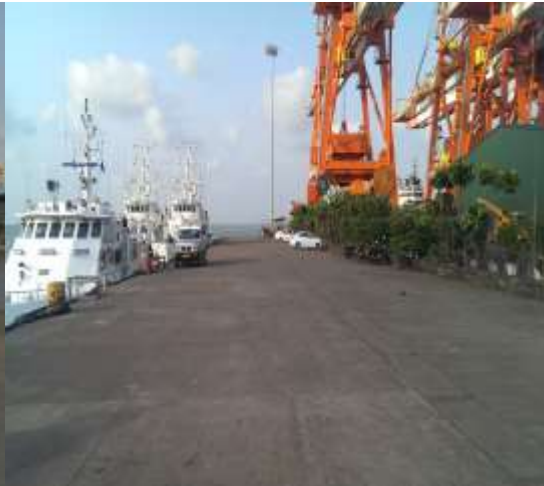
Berth No. 4 is under the operation and management of Mormugao Port only and was commissioned in the year 2010. This berth is being used for small crafts only. It is a RCC constructed. The length of the berth is approx. 190 mts and width is 16 mts and depth is 8 mts.

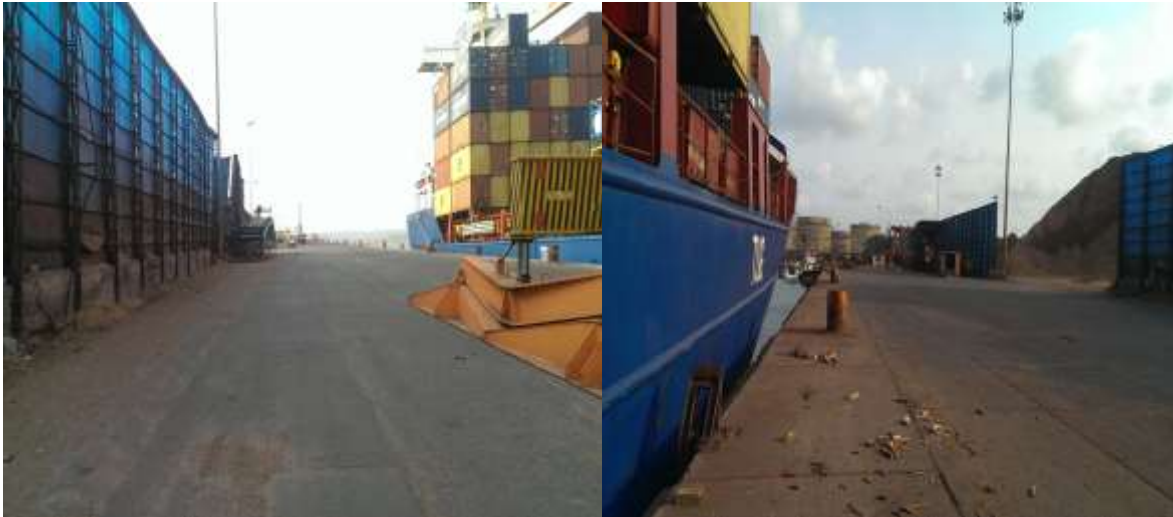
Berth No. 10&11

Berth No. 10 and 11 are under the operation and management of Mormugao Port. It is being used as a general cargo berths and commissioned in 1985 and 1994 respectively and having a draft of 11.00 mts and 12.50 mts. It is a RCC constructed supported with piles. The length of the berth no. 10 & 11 is approx. 250 mts and 270 mts.

There are three dedicated storages provided for material export/import purpose at berth no. 10 & 11 which belongs to Mormugao Port. At present, wood chips have been stored in open shed and steel coils have been stored in closed shed.

There is a possibility of fire at berth no. 10&11 where combustible materials like wood chips have been stored in open shed area at other side of the berth.

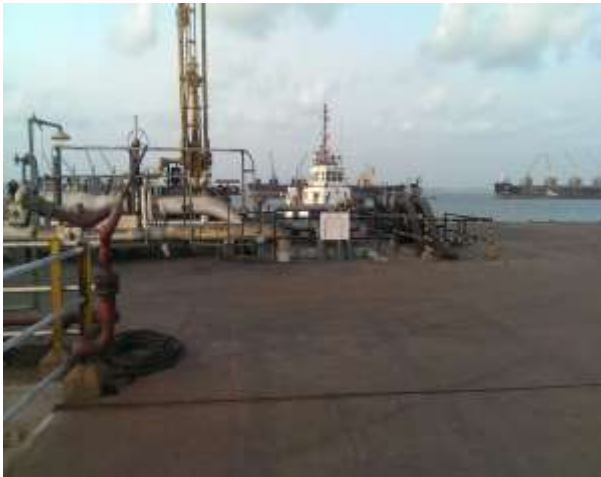
Berth No. 8

Berth No.8 is a Liquid cargo handling berth. The commodities like POL product, Furnace oil, Ammonia and other liquid products are being handled and managed by private agencies at this port. Berth No. 9 is dedicated for the handling of iron ore with mechanical ore handling plant (MOHP) and it belongs to Vedanta Limited. The structure is of concrete cribs with RCC decking. The length of the berth no. 8 & 9 is 260 meter and 360 meter respectively.

Oil storage tank which is installed at berth no. 8 can lead to an explosion though it doesn't come under the custody of Mormugao Port.
