Aquatic Diving & Marine Services Company

Ref No:ADMSC/MPT-31/10-15/62-C

**SUB :- UNDERWATER INSPECTION OF SUNKEN VESSEL WRECKS
NEAR BERTH NO. 10 & 11, MORMUGAO HARBOUR GOA.**

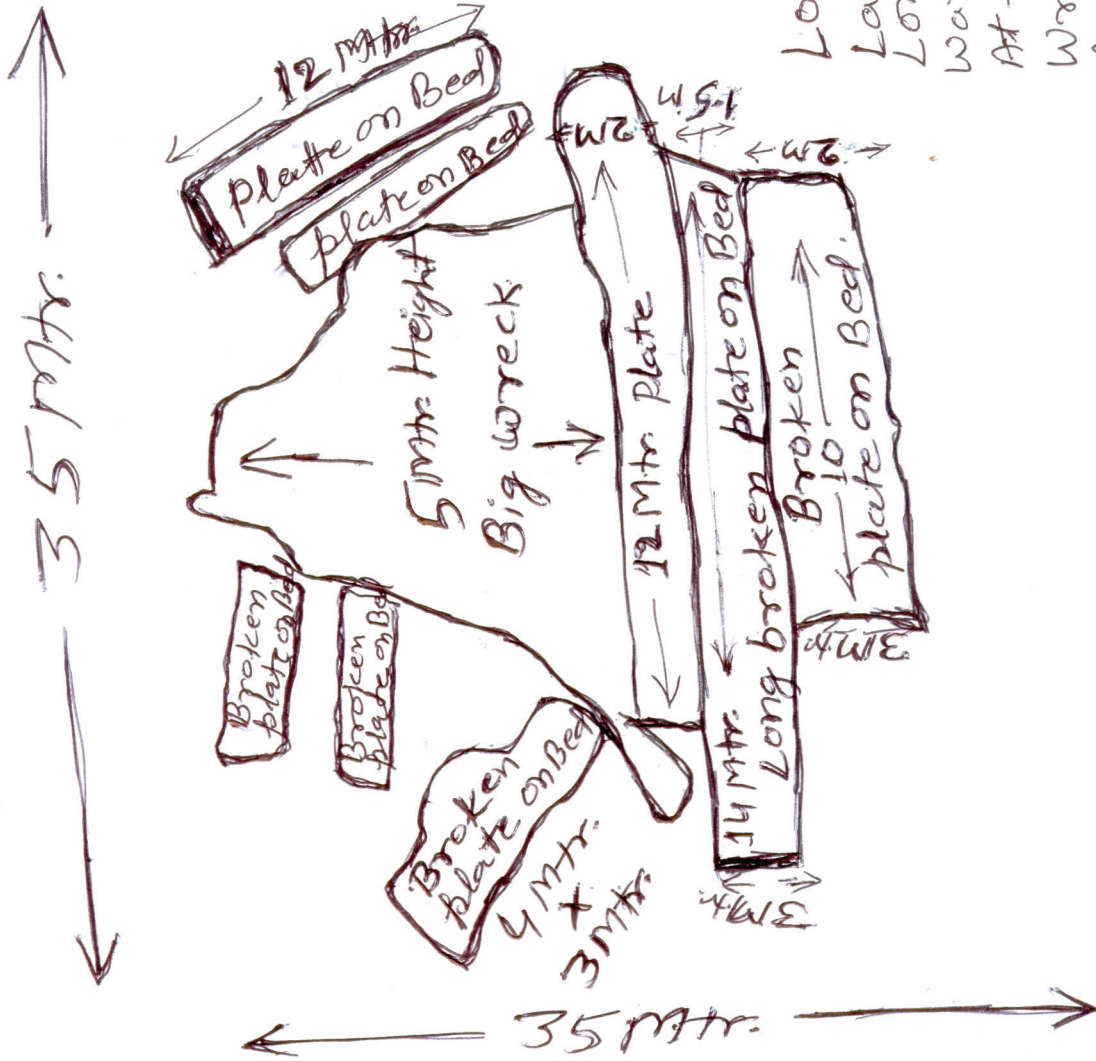
The wrecks are seems to be more than 35 years old in the vicinity. The wrecks are MS built and scattered all around in the area of 35 mtrs X 35 mtrs . The wrecks are lying on the sandy seabed surface and resting on each other having a maximum vertical height of 05 mtrs. The plates are removed by underwater cutting in many places due to that the wreckages are in irregular shape. The visible plates are of different sizes the bigger plates are in size of 14 mtr Length X 3mtr Breadth , 12mtr Length X 2mtr B , 4mtr L X 3mtr B , 12 mtrs X 1.5 mtr , 9 mtrs L X 3 mtrs B . There are many small plates scattered in the area on the sea bed . Small pieces of wooden boat were also noticed on the sea bed area. Marine growth were also noticed on the wrecks.

Location of Wreck
 Lat → 15° 24' 17N
 Lon → 73° 48' 63E
 Water Depth 4.5 Mtr.
 AT - 10:00AM on 10.10.2015
 Wreck Height - 5 Mtr.
 Area 35 Mtr X 35 Mtr.
 sea Bed Sandy Area.

Suggestion : The wreckages of the sunken vessel can be removed only by underwater cutting and floating crane barge to lift it .
