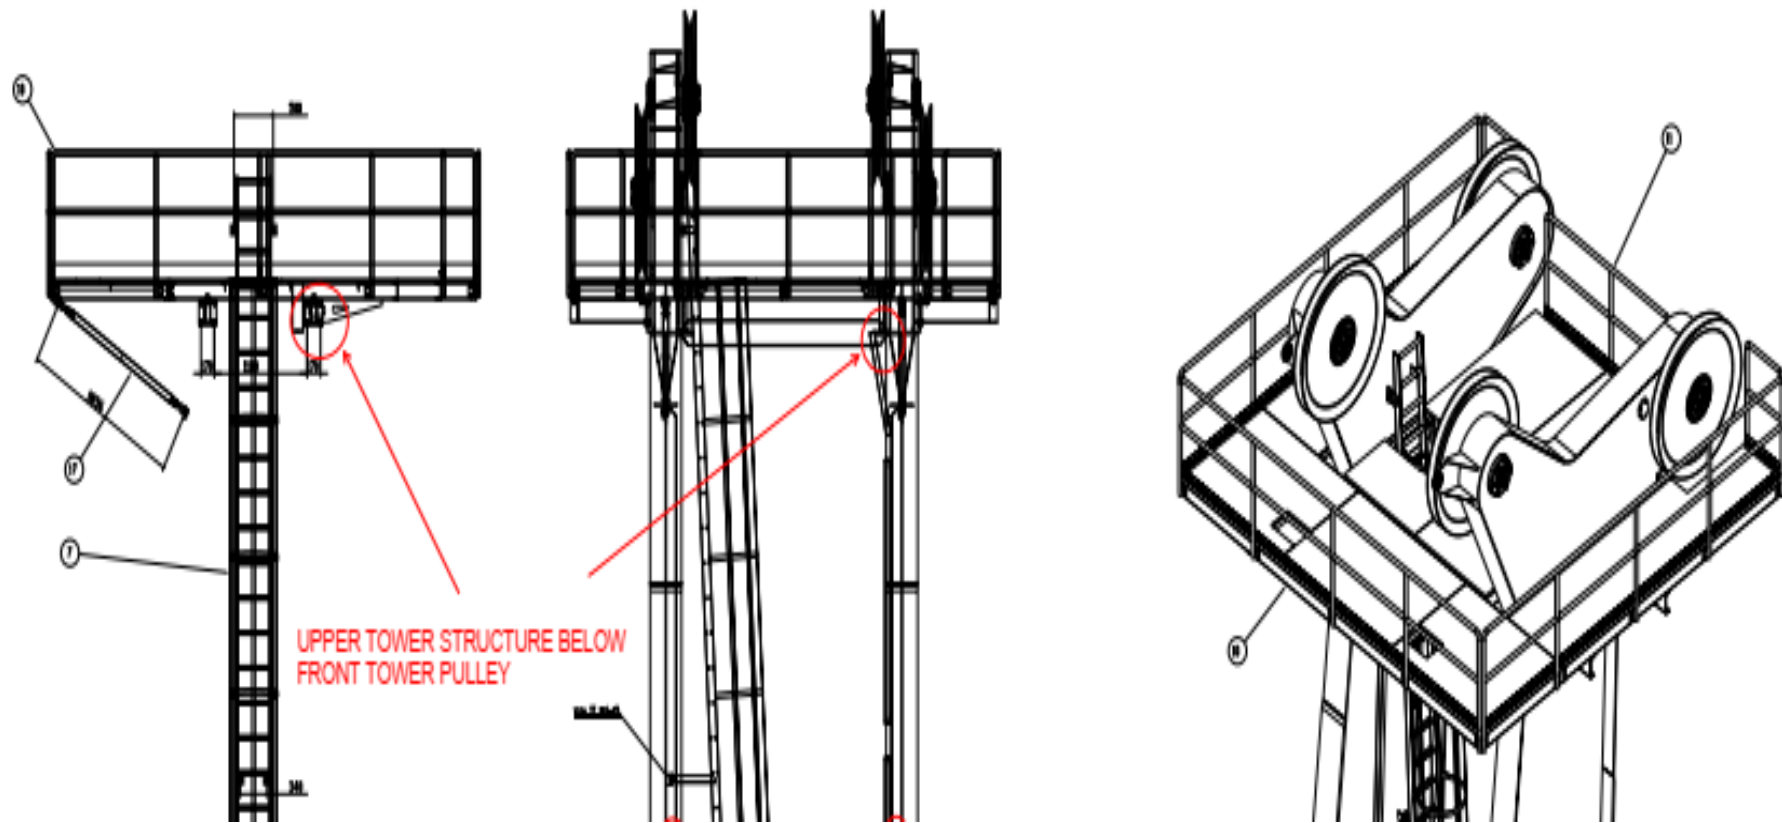
**N. B.:** The above marked areas (four locations) beneath the Tower Pulley Structure are to be checked/inspected for cracks by carrying out Non-Destructive Testing and to be rectified by welding, in case of any cracks.
